## HTM NEWS & VIEWS

# ‘No Problem Found’ Service Calls—Keep Digging

Alan Lipschultz

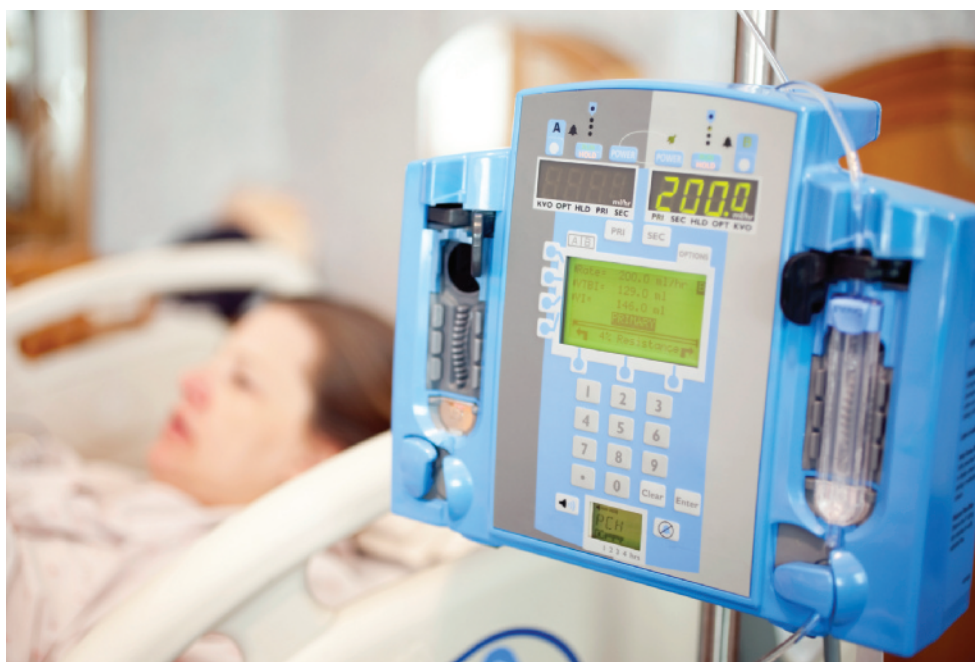
Infusion pumps keypads and displays can pose a challenge to nurses. Healthcare technology management professionals can play a crucial role in determining the root cause of any problems.

One day, a staff nurse in L&D mentioned to a clinical educator that by pressing any of the digit keys on the pump slowly and lightly, one key press resulted in double entry on the pump. For example, by pressing the "3" key, the pump would register "33." The clinical educator immediately phoned me to come witness this demonstration. Once shown how to "incorrectly" press the key, I was soon able to replicate the problem on any pump in our fleet. This was clearly an OMG moment!

phenomenon was called "key bounce" due to normal muscle tremor in the finger. It used to be a common problem when push button phones were first introduced until engineers learned to design in an a debounce circuit to filter out multiple presses too close together in time to be real. We both agreed that this was a major problem.
